# Manhole Inspection Summary

Manhole # S06CC2015MH

**Location** Address: **6923 FIELDCREST RD**

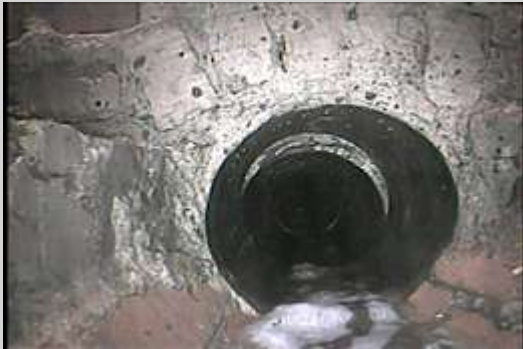
### 8 in. Circular Gravity Sewer Pipe Out @ 12 O'Clock

Rod and Bar (Angled)

Pipe Material: **Clay** ☐ Pipe Lined

Infiltration: **None** Pipe Seal Cond: **Unknown**
